**Lesson learning for hardware installation
and engineering survey**

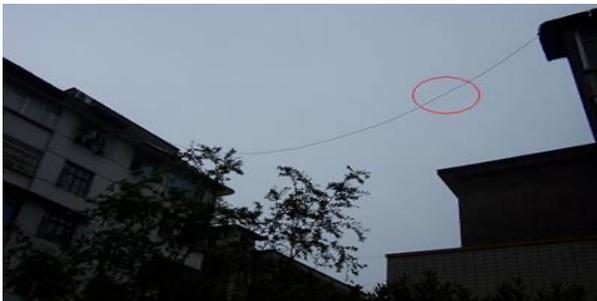
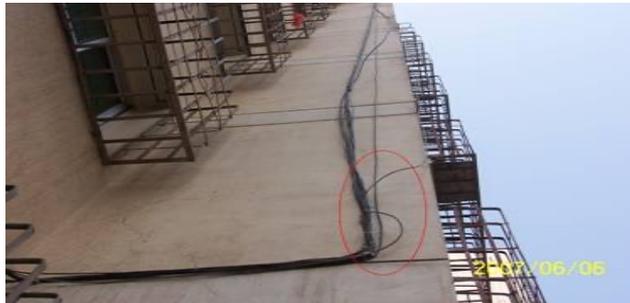
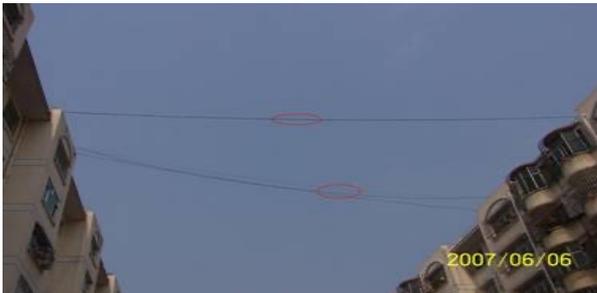
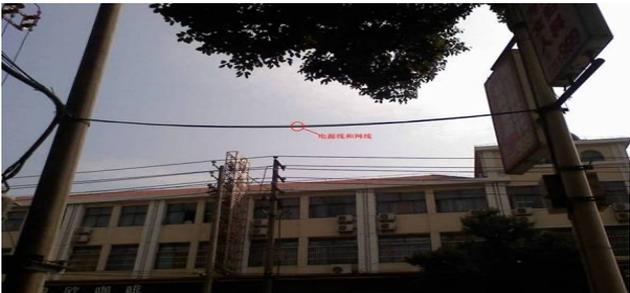
Case 1 - Outdoor overhead wiring

Case: Some ports of a product were damaged after a thunderstorm.

Root cause : After on-site inspection, it was found that overhead flying network cables between buildings are very common.

Solution: Try to avoid outdoor wiring. If it is unavoidable, if it is impossible to lay all outdoor cables underground, the overhead cables should pass through a metal pipe 15 meters before entering the room, and both ends of the metal pipe should be grounded. After the cable enters the room, a signal arrester should be installed at the corresponding interface of the equipment.

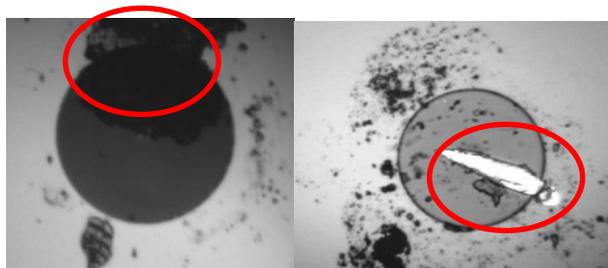
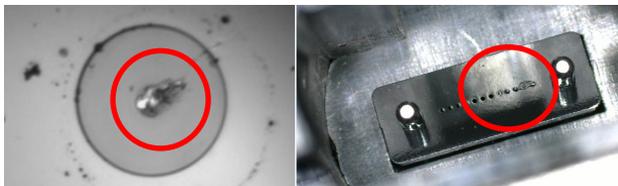
Dust contaminate the optical port

Case: Intermittent errors or even interruptions in fiber optic connections.

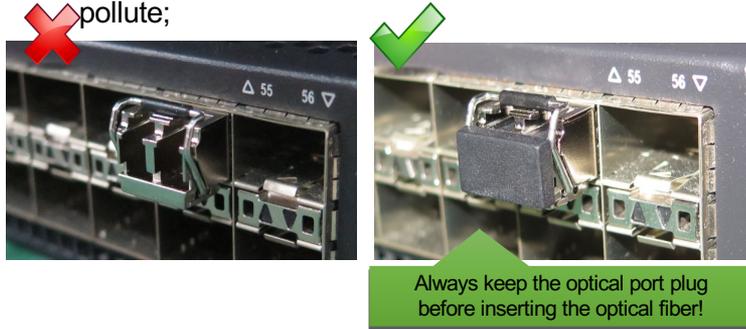
1. The optical port of the optical module is prematurely/directly exposed to the environment, and dust objects enter and pollute;

- ① Keep the IT room environment clean and free of visible contaminants;
- ② After the optical module is inserted into the switch, keep the optical port plug until the optical fiber is inserted;
- ③ The optical fiber of the equipment room wiring should keep the protective cover until the optical module is inserted;
- ④ If you need to plug and unplug the fiber multiple times, you need to pay attention to protect the fiber end face to avoid damage or sticking dust;
- ⑤ Best to clean the end face of the optical fiber with dust-free paper or a fiber end face cleaner before inserting the optical module.

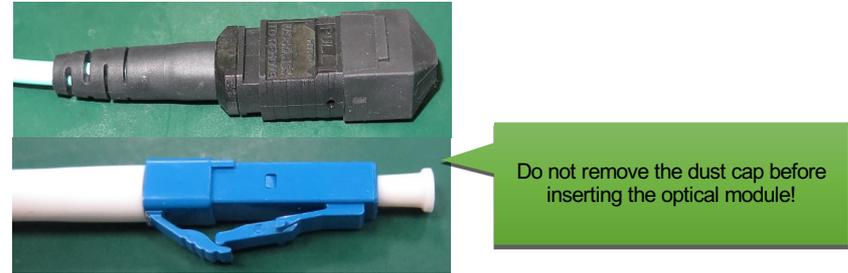
2. The end face of the optical fiber connector used is not protected, and it has been polluted before inserting the optical module. After the insertion, the optical port of the optical module is polluted twice;

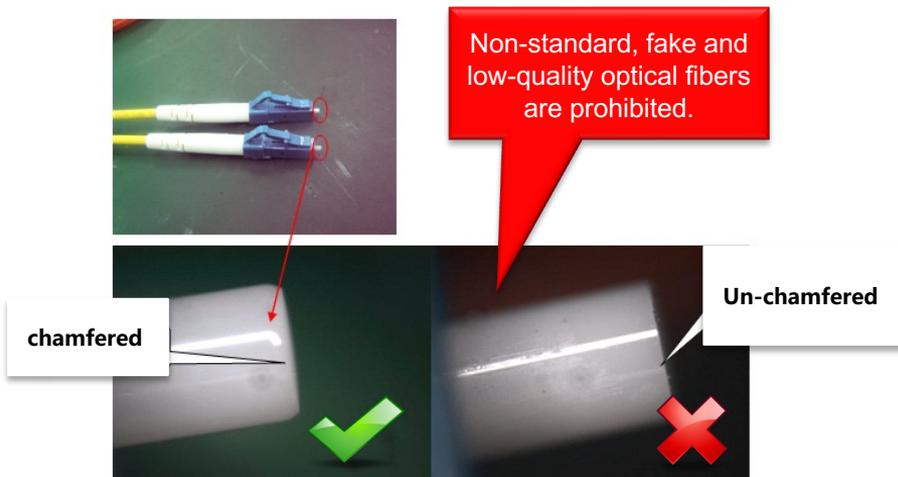
Schematic diagram of optical port damage

Case: The damage to the optical port results in packet loss and failure of packet forwarding.

Root cause : After on-site inspection and positioning, it is mainly aimed at the optical fiber of the LC interface. If non-standard optical fiber is used:

- 1) It may cause damage to the components in the optical port;
- 2) Interfering and rubbing with the inner wall of the optical port during the insertion process may generate debris and cause the port to be blocked

Solution: Refer to the judgment method of the LC fiber standard, and use the standard fiber for networking

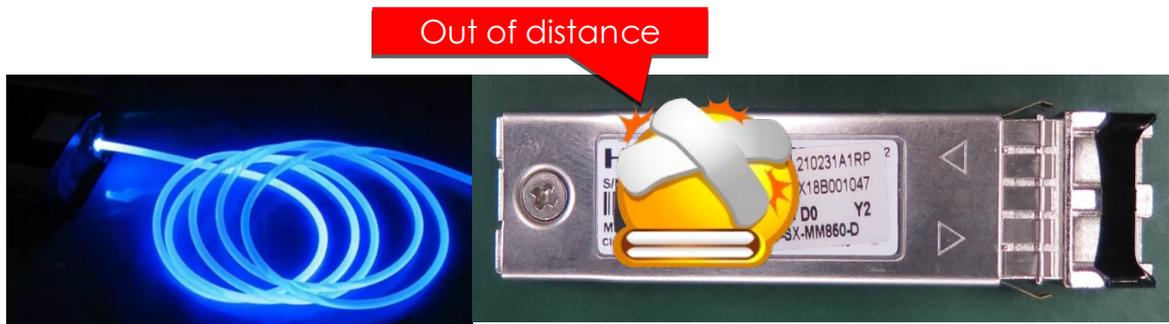
Case 4 - The received optical power of the long-distance optical module exceeds the standard

Case: long-distance optical modules fail to return. After analysis, they are all caused by over-power and over-current of the APD chip at the receiving end.

Root cause : the received optical power is higher than the saturated optical power of the module, causing the APD chip in the receiving end to burn out. For example, the -4dbm light received by the module is higher than the -6dbm saturated optical power of the module.

- ① It is forbidden to insert the optical fiber without confirming the received optical power, and command to read the receiving and transmitting light range of the optical module before inserting;
- ② If possible, use an optical power meter to test that the receiving and transmitting power is in the normal receiving range, and then connect the optical module;
- ③ When using a long-distance optical module, the receiving power should be reserved more than 3dB compared with the receiving sensitivity. If it is not satisfied, an attenuator needs to be added;
- ④ Under any circumstances, the above-mentioned long-distance optical module cannot be directly tested for loopback, and an optical attenuator must be connected if necessary;

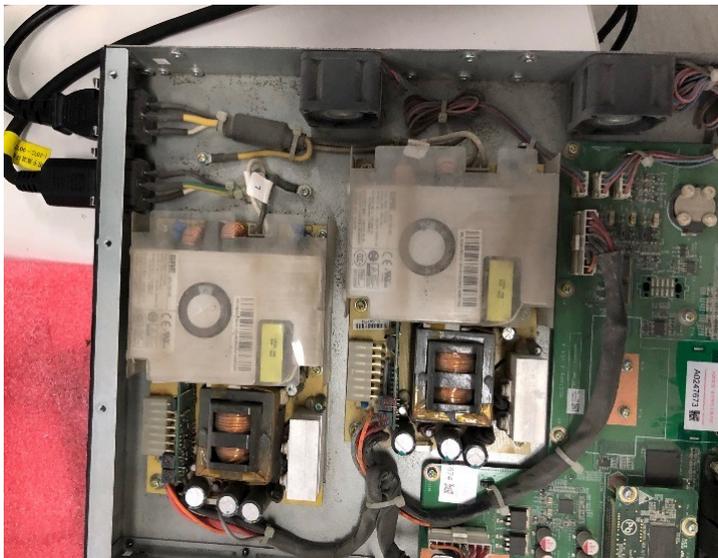
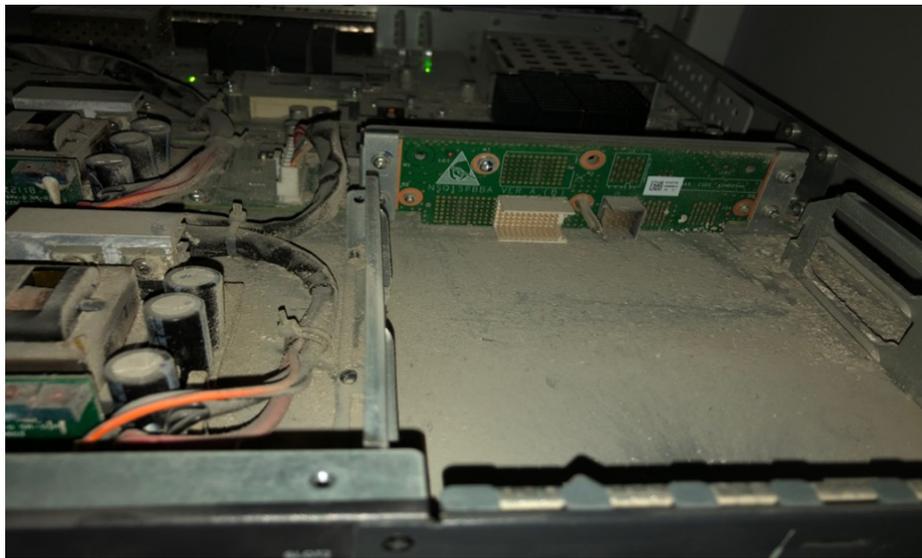
Case 5 - Dust causes equipment abnormality

Case : 11 *equipment alarms;

Root cause : Returning the faults parts to disassemble the equipment, it was found that there was a lot of dust inside, and some parts even appeared muddy.

Solution : Dust the equipment room, It is recommended to add dust filters to the equipment room cabinets to prevent possible re-contamination.

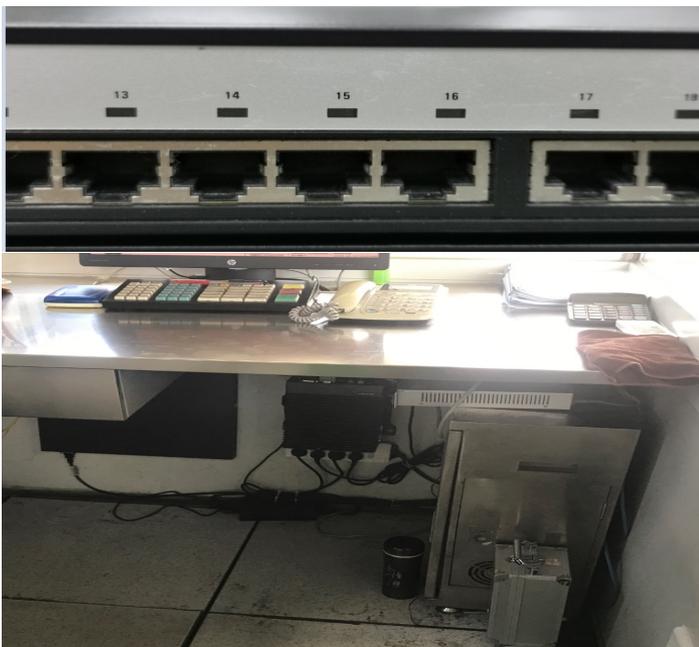
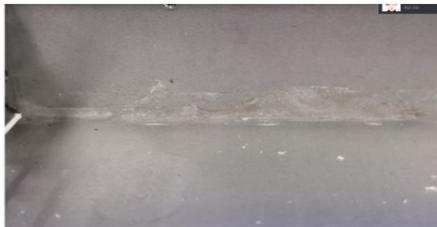
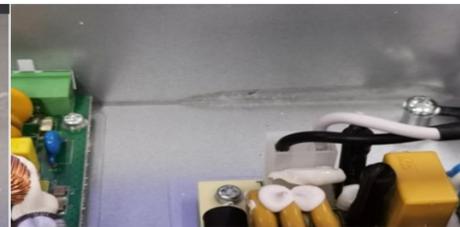
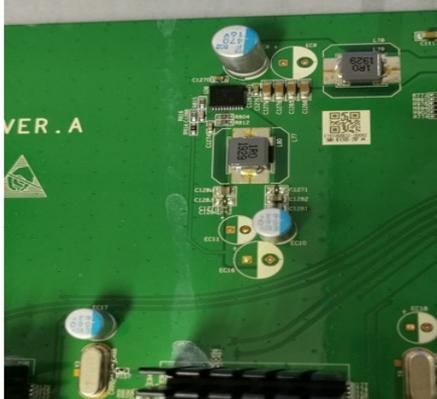
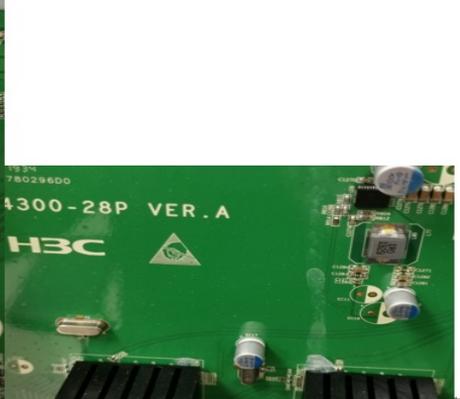
Case 6 – Equipment damage due to water entering

Case: IE4300 hardware failure ;

Root cause : The on-site environment was hot and humid, and the disassembly found that the internal water had obviously entered, resulting in a short circuit of the main board.

Solution : In an environment with high humidity and condensation, it is recommended to install it horizontally to prevent condensation from flowing into the device from the DIP switch or network port.

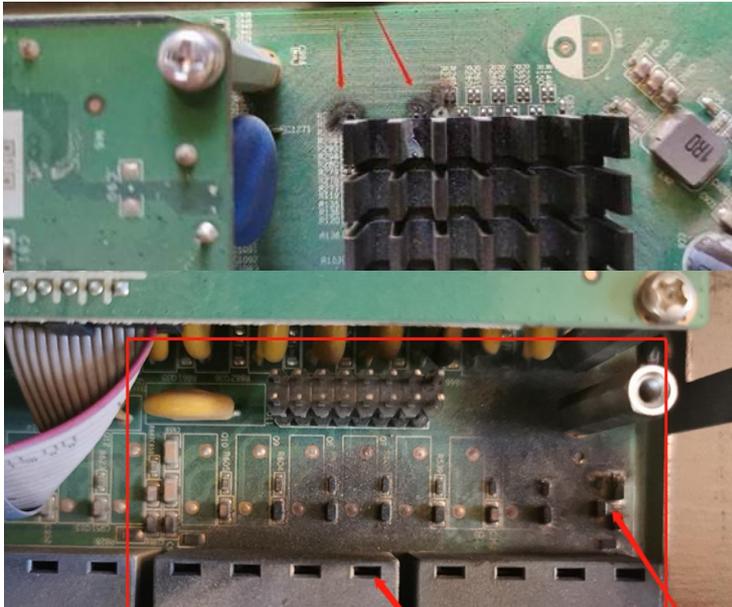
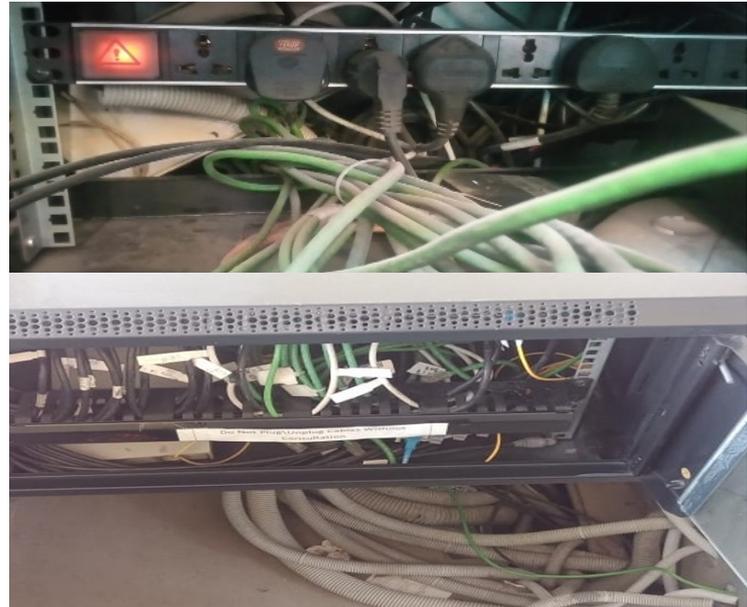
Case 7 - S5130S-HI Internal components burned out H3C

Case: POE fails due to the hardware is damaged.

Root cause : Returning the faults parts to disassemble the equipment, it was found that many components of the main control board were burned, because the high-voltage input coupled to the network port broke down the components.

Solution : On-site highway toll station S5130S-HI has mixed wiring of strong and weak current, no grounding, and a lot of dust. It is recommended to separate the strong and weak points (with an interval of more than 30cm), standardize the grounding, and install a dust-proof net.

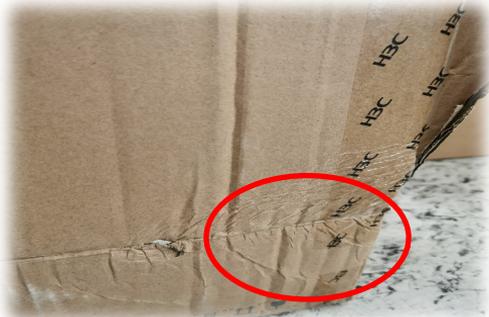
Outer box squeeze deformation

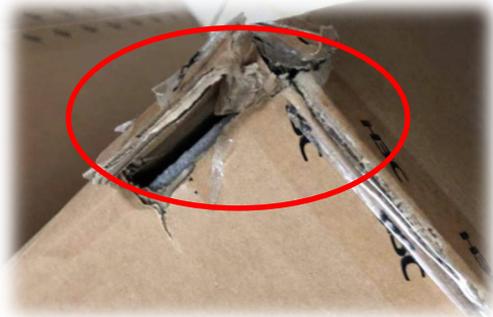
Torn outer box

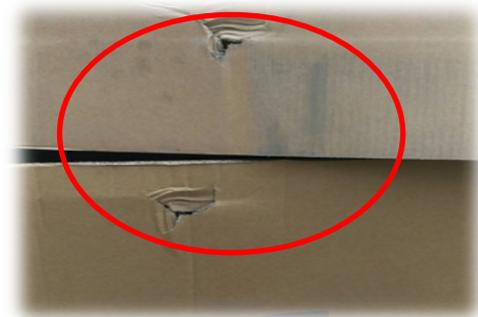
Hole in the outer box

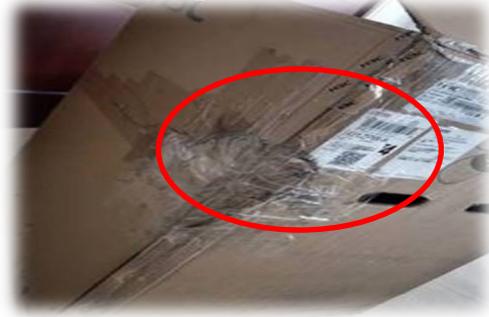
Secondary treatment of damaged outer box

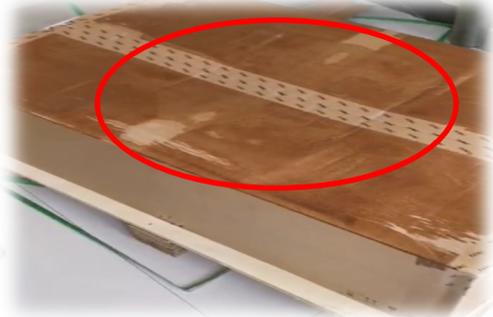
Wet outer box

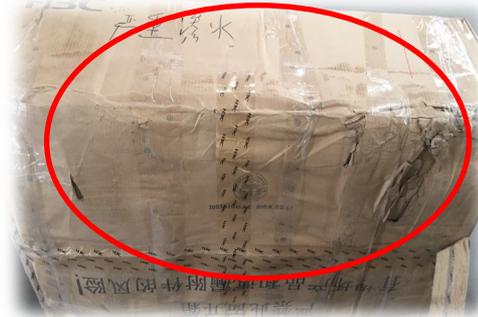
Water seepage from the outer box

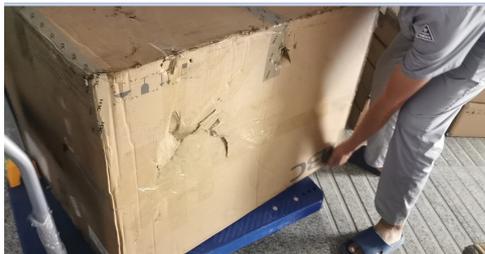
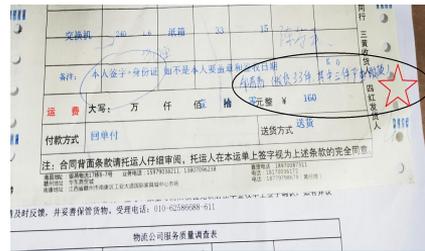
Background : 33 boxes of equipment for a project, found abnormal when signing for receipt, immediately took photos and contacted TS, TS reported back to the customer quality department, and found that the cartons were damaged and deformed after the inventory.

On-site feedback : The agent received the goods at noon on September 26 and found that 3 of the goods were damaged in the outer box. They immediately contacted the representative office TS. TS immediately contacted the customer quality department on WeChat, considering the urgent needs of the customer, sign the receipt and note the damage, and record the damaged photos , If the subsequent unpacking is found to be damaged in transportation, you can make a claim to the general agent based on the receipt.

Summary : The signed receipt is the proof of whether the handover between the two parties is intact. Please check it and cleanly handed over. Subsequent issues are not disputed, and the processing time will be very fast.

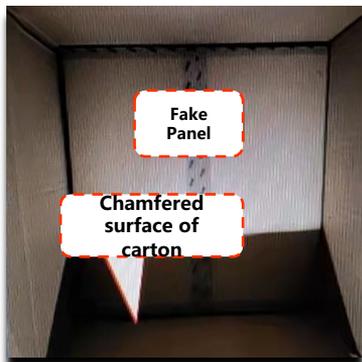
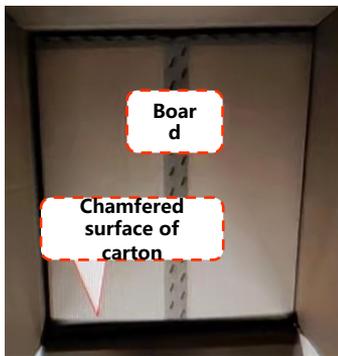
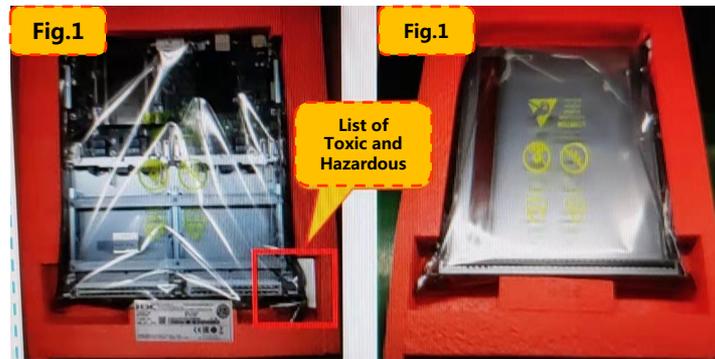
Unpacked carefully, the device is hidden

Background: Problem feedback: The on-site engineer of a bank project in Heilongjiang reported that when the RT-FIP-660 interface card was unpacked and installed, it was found that there were only empty sheet metal parts and no actual circuit board.

The packaging of this product is quite special. There are 2 cartons stacked up and down in the carton, the upper carton is filled with boards, and the lower carton is equipped with a windshield fake panel. The carton was not found.

Summary : During the unpacking process, it is necessary to carefully check whether there are other equipment in the carton, and do a good job of on-site investigation.

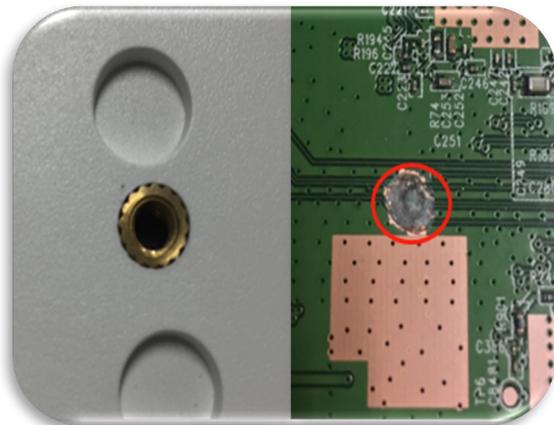
Scenario 1: The wrong screws are used when racking on

Impact: internal parts fall off, PCB damage

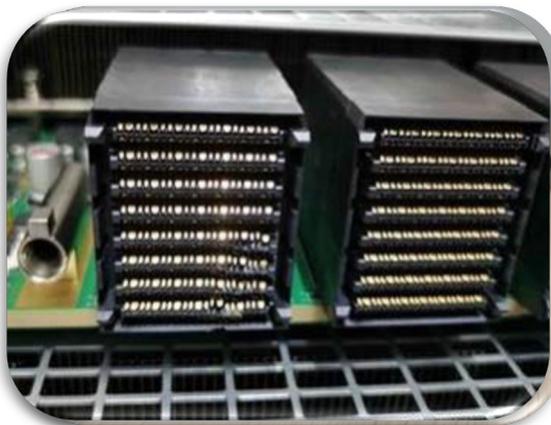
Scenario 2: The board bumps after unboxing

Impact: Deformation of the linker needle (back needle)

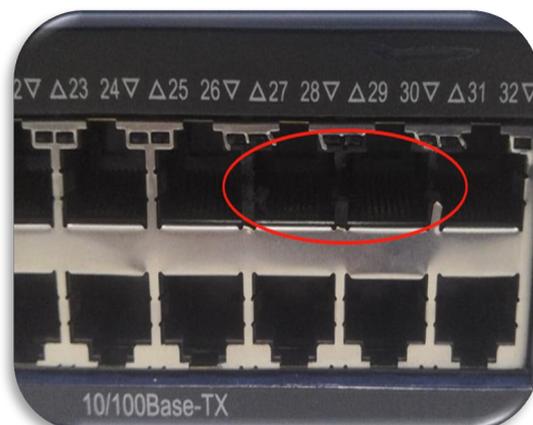
Scenario 3: Unstandardized plugging and unplugging of network cables

Impact: The network port connector is damaged

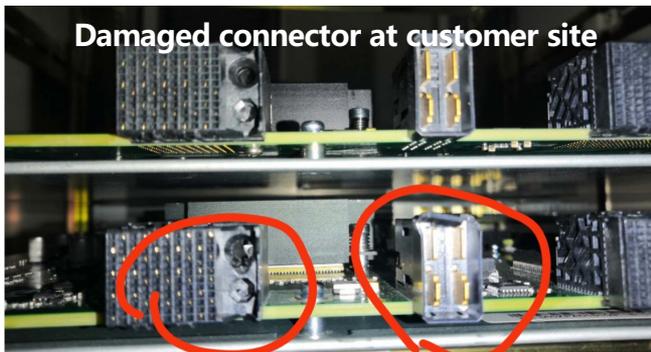
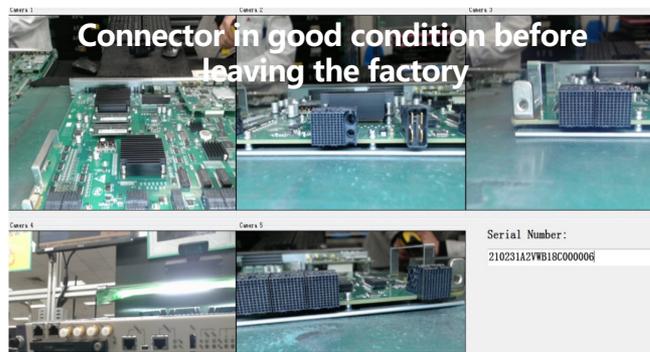
On site unpacking with insufficient protection leads to deformed pins

Background: The board was damaged during installation, and it was confirmed on the spot that the pins of this board were deformed.

According to the pictures provided on site, both the power connector and the data connector are damaged. It is confirmed that the connector picture is intact through the monitoring before leaving from the factory, and it is judged that the damage is not a factory problem, but damaged after unpacking.

Summary: Bare board transfer/stacking is prohibited after unpacking on site. If there are special circumstances, please be sure to take care; before inserting the chassis, be sure to check the appearance of the connector again to avoid chassis damage.

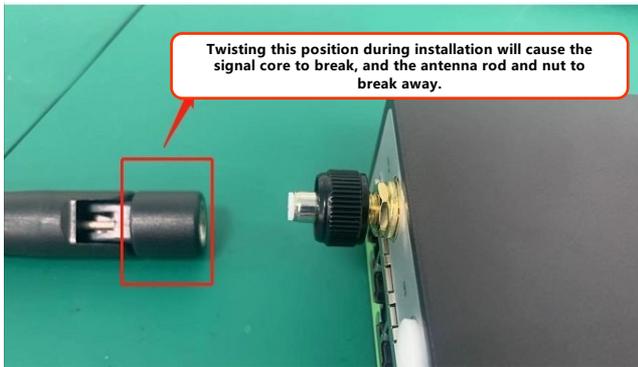
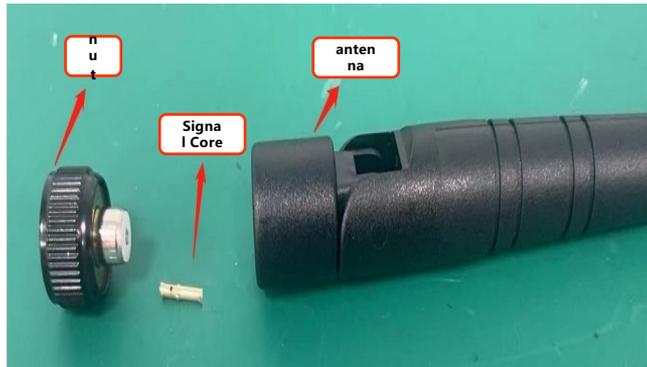
Broken antenna due to excessive force when installing

Background: A customer of a distribution project reported that an MSR810 antenna was broken when unpacking.

According to the pictures provided on site, it is analyzed that the antenna is screwed when the customer is installing on site, and the antenna is continued to be screwed when the antenna nut is not rotating. The signal core connecting the antenna nut and the antenna rod is broken by force, causing the antenna nut and the antenna rod to break away.

Summary: Improperly installed antennas on site may damage the antennas. Please refer to the "Installation Guide" for the installation of the MSR810 antenna: screw the antenna clockwise to the antenna port of the router, and be careful not to apply excessive force to avoid damage to the antenna.

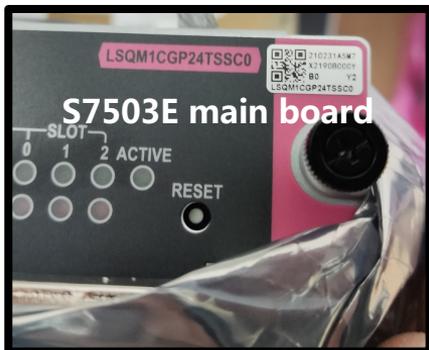
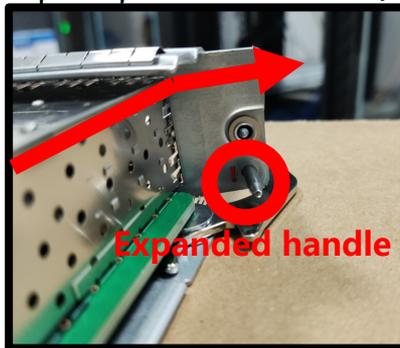
Board damage due to mismatch

Background: A school in Shaanxi reported that an S7503E master controller could not be inserted into the chassis, and the handle bar was deformed.

After investigation, it was found that the board in question was the S7503E master controller, and the product was designed with positioning pins. The chassis used by the customer on site is the S7506X. This product does not have positioning holes. The two are not compatible and cannot be mixed. Looking at the picture of the board, the handle is slightly expanded, but the outer box is intact. It is judged that the customer is deformed by force after improper operation after unpacking on site. .

Summary: Similar models of equipment in the contract order should be put on the shelves with special attention to avoid equipment damage caused by human error.

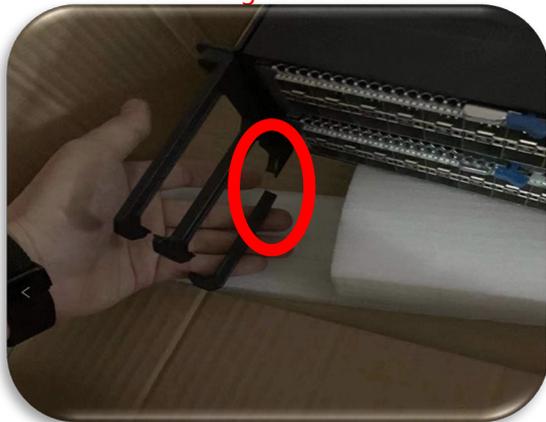
Scenario 4: Wrongly use the cable management frame as a handle

The cable management frame breaks

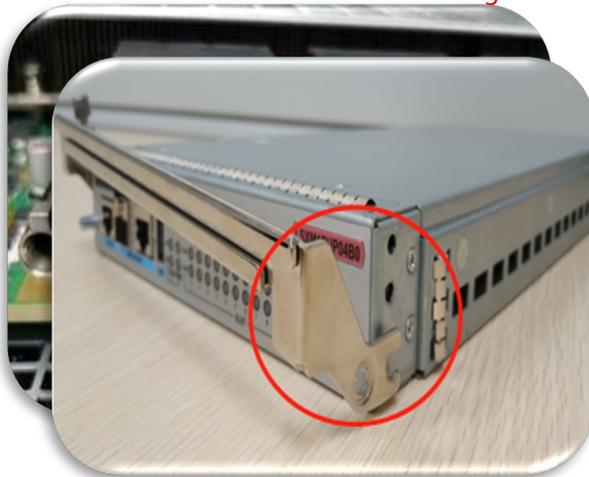
Scene 5: Wrongly use the handle bar as a handle

The handle bar wrench falls off after being stressed

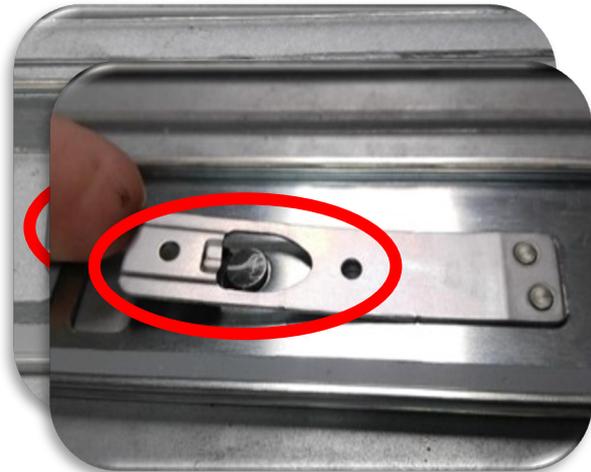
Scenario 6: Irregular installation of slide rails

Excessive pulling of shrapnel causes permanent deformation

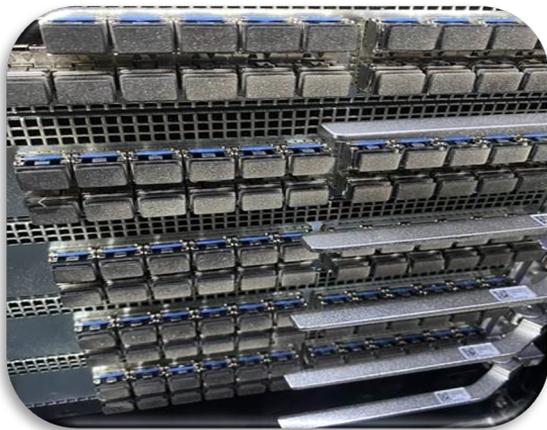
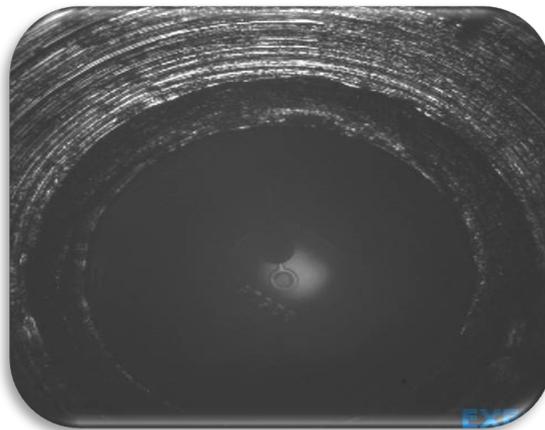
Scenario 7: The interface indicator is off due to the dirty optical module

Return the normal optical module by mistake

The storage environment of the optical module should be clean and dry, and the interface of the optical module should be kept clean when installing on the rack.

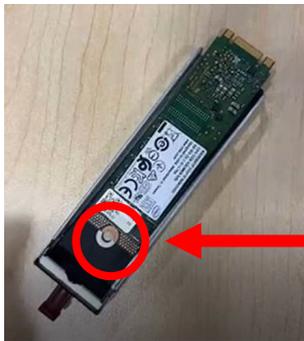
Background: On-site technicians of a project in Hong Kong reported that the SSD hard disk was loose when the F1000 security product was installed with the SSD hard disk. The feedback video clearly shows that the hard disk PCB board can slide back and forth in the hard disk slot.

This type of SSD hard drive is semi-finished at the factory and needs to be assembled on site. According to the video feedback on site, it was found that the screws fixing the hard disk PCB board were not installed, which caused the hard disk PCB board to loosen, and the on-site personnel slide the PCB board back and forth, which may cause damage to the device.

Screw is not fixed

Summary: Please refer to the H3C product installation manual before installing unfamiliar products. If it is not covered in the manual, please contact the local service in time. Do not dispose of it by yourself to prevent man-made damage. Please accumulate experience and organize learning regularly.

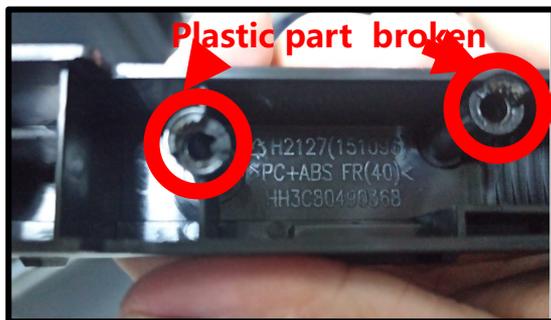
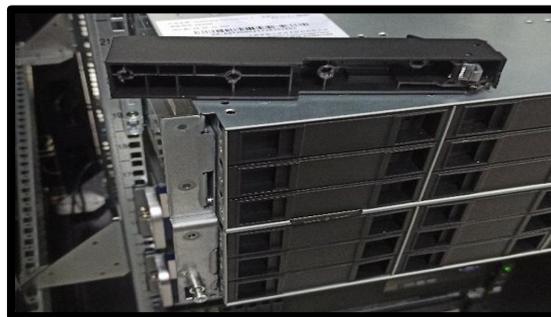
The plastic part of the smart mounting brackets are broken

Background: A project of Aishu OEM server reported that a R4300G3 server mounting bracket was damaged while unpacking.

After inspection, when the equipment was packaged in the factory, the monitoring showed that the mounting ears were intact. According to the photos provided by the customer on site, it is determined that the cause of the failure is that the customer grabs the smart mounting ear to lift the server when moving the server, which causes the plastic part of the smart mounting ear to fall off.

Summary: The mounting ears for devices such as servers and storage are not load-bearing. Please use the lift on the side of the chassis to carry the device.

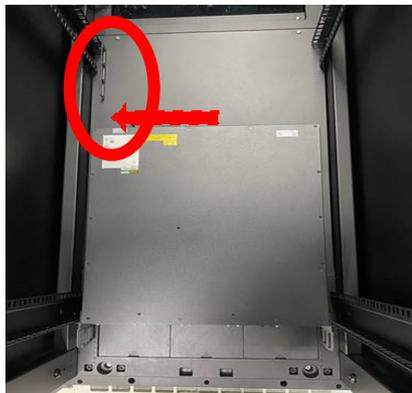
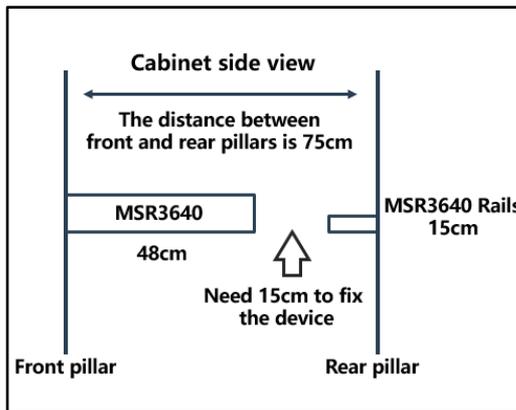
The site survey is not perfect and the devices cannot be installed on the rack

Background: The MSR3640 routers at multiple overseas offices of an Internet company are equipped with standard slide rails, which cannot be matched with the on-site cabinets.

The standard sliding rail in the "MSR3600 Router Installation Guide" requires a range of 310mm to 440mm between the front and rear pillars of the cabinet, and special sliding rails are required if the distance exceeds this range. The front and rear pillars of the on-site cabinet are 750mm, so the standard slide rails cannot be installed on the rack. It is determined as a site survey problem.
